ISSUE

My Wine Saver PRO® is leaking argon.

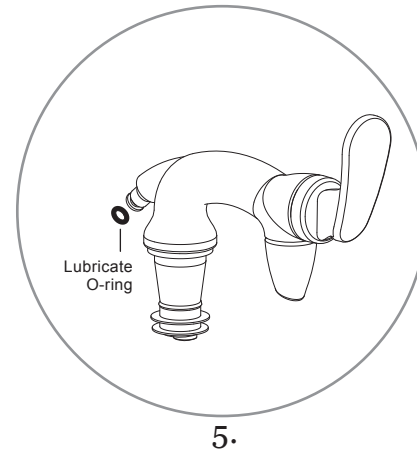
1. Ensure Tap Head assembly is fully seated in bottleneck and the rubber bottle seal fins are not scratched or damaged. In some small bottlenecks the system's pressure can push the Tap Head assembly up slightly which may allow argon to escape.
2. Ensure Argon Gas Cylinder is screwed in tightly to the Regulator Unit. To fully tighten, after feeling the seal break continue to tighten 3 to 4 turns.
3. Ensure Quick Connect Coupler is fully seated on Tap Head assembly. When fully connected you will hear a click from the metal button engaging on the stem.
4. Ensure Quick Connect Coupler Stem and Stem O-ring on Tap Head assembly are clean and free of possible damaging debris.
5. Ensure O-ring on Tap Head assembly is lubricated. If dry, lubricate with a small amount of common vegetable oil.
6. Ensure Quick Connect Coupler Stem on Tap Head assembly is not cracked or damaged in any way.

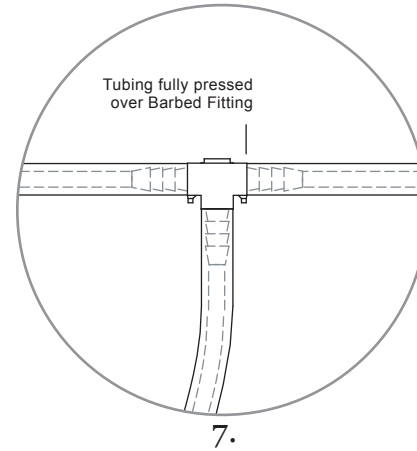
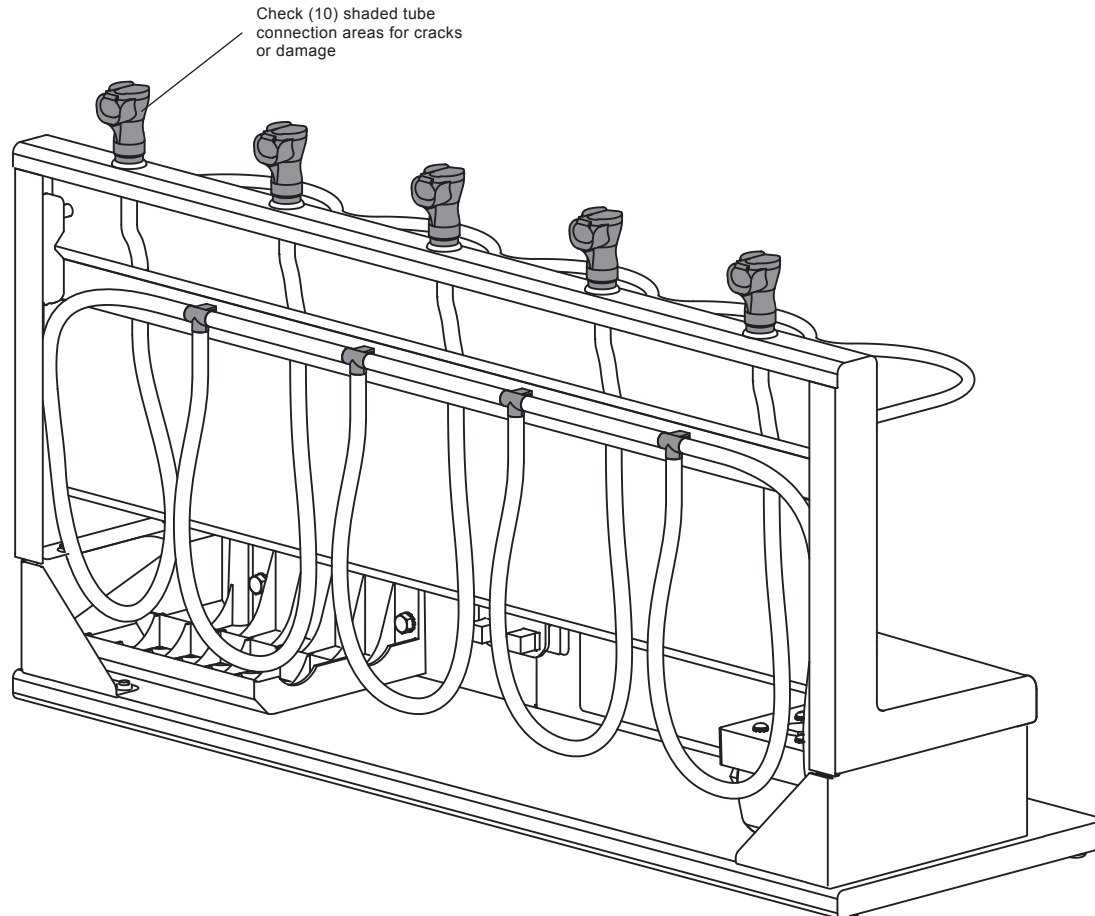
7. Ensure all tubing and tubing connections are fitted correctly and have not been damaged or cracked. Tubing should be fully seated over all barbed fittings.

If argon continues to leak you may need additional help locating the source. To more accurately determine the location of your leak, brush all connection and fitting areas with soapy water and watch for bubbling, a sign of leaking argon.
